ANNEALED FOIL FATIGUE SENSOR DEVELOPMENT

LOCKHEED-GEORGIA COMPANY

TECHNICAL REPORT AFFDL-TR-71-127

MARCH 1972

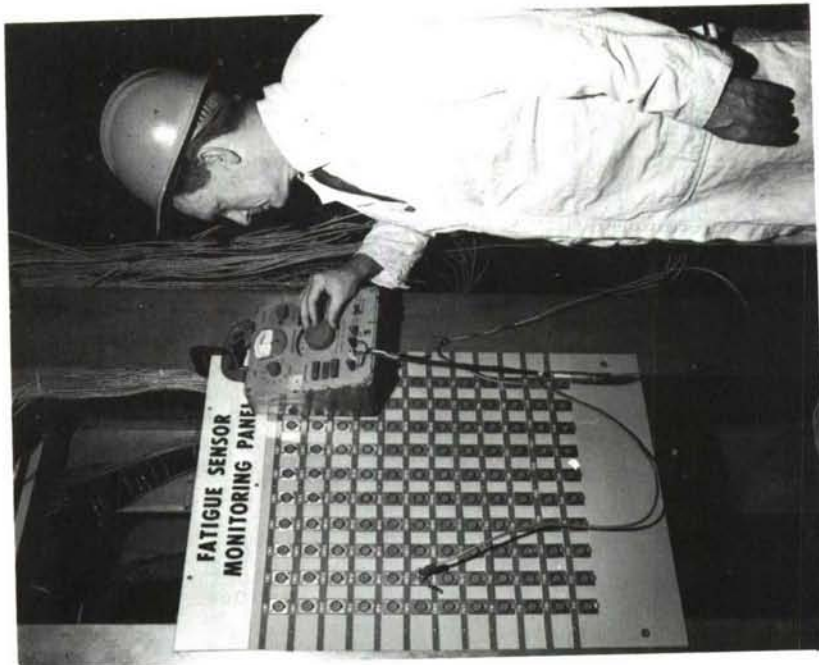
FIGURE 22. SAMPLING OF SENSOR RESISTANCE CHANGE

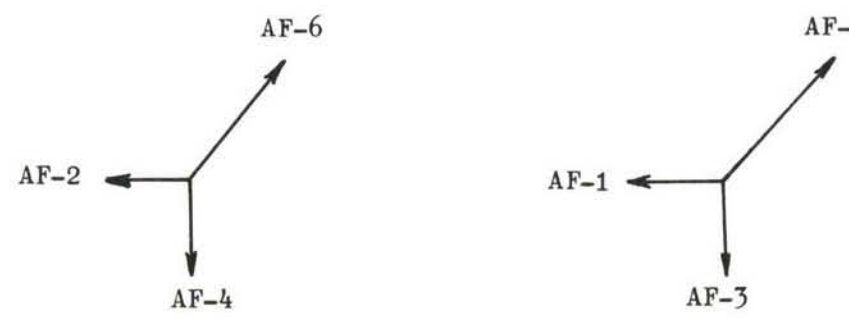
Separation of data according to assemblies has been followed in the graphic displays (Figs. 56 through 62) of sensor response. As a case in point, the sensors located at the front beam vertical fin attach points, i.e., AF-3, AF-4, AF-5, and AF-6 felt basically the gust and maneuver loads (VGM and LGM). These sensors, however, indicate an adequate response to taxi, ground-air-ground, and buffet. These particular sensor readings are displayed in Figure 56 and indicate the relationship of the distributed sensor resistance changes at the "dagger" type attachment fittings as well as relative amplitude of cyclic load exposure. The division of sensor cumulative resistance changes in the dagger fitting is partially obscured by the variation in sensor multipliers used. In retrospect, a common multiplier for this fitting would have simplified the analysis; however, the relationship of sensor readings can be vectorially represented as follows:

The figure contains two vector diagrams. The left diagram shows a central point with three arrows: one pointing up and to the right labeled 'AF-6', one pointing horizontally to the left labeled 'AF-2', and one pointing vertically down labeled 'AF-4'. The right diagram shows a similar central point with three arrows: one pointing up and to the right labeled 'AF-5', one pointing horizontally to the left labeled 'AF-1', and one pointing vertically down labeled 'AF-3'.

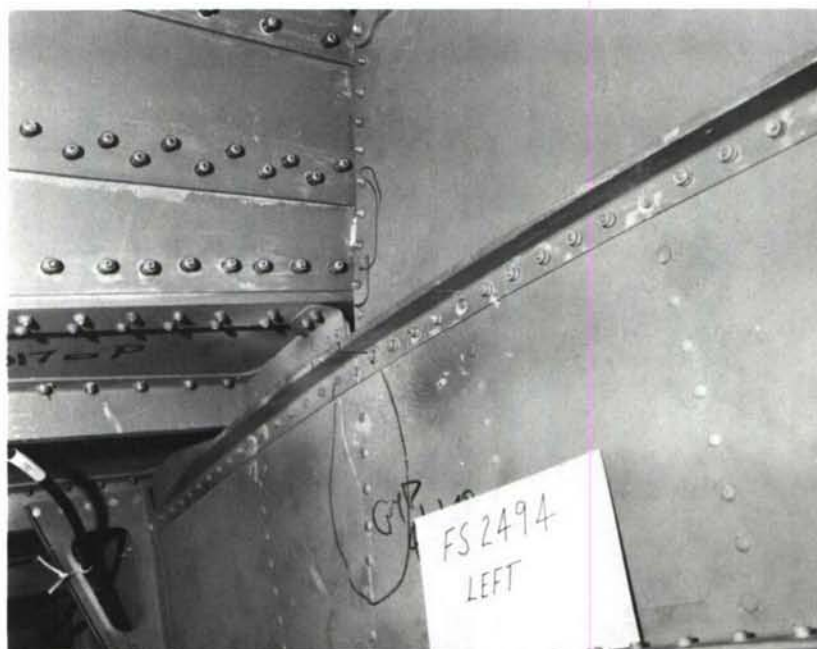
FIGURE 65. FATIGUE CRACK AT NEXT AFT FRAME STATION

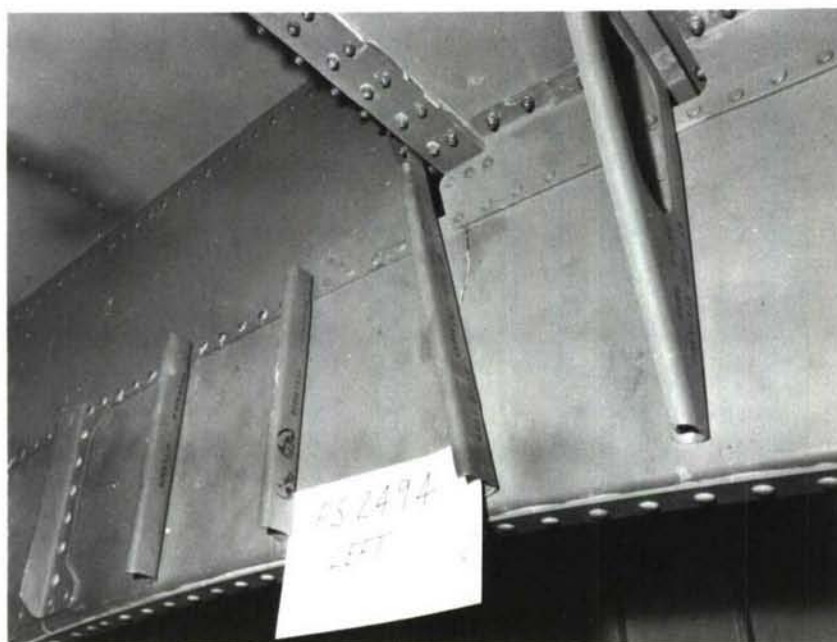
FIGURE 67. FATIGUE DAMAGE AT FUSELAGE FRAME STATION F.S. 2494.
LOOKING AFT.

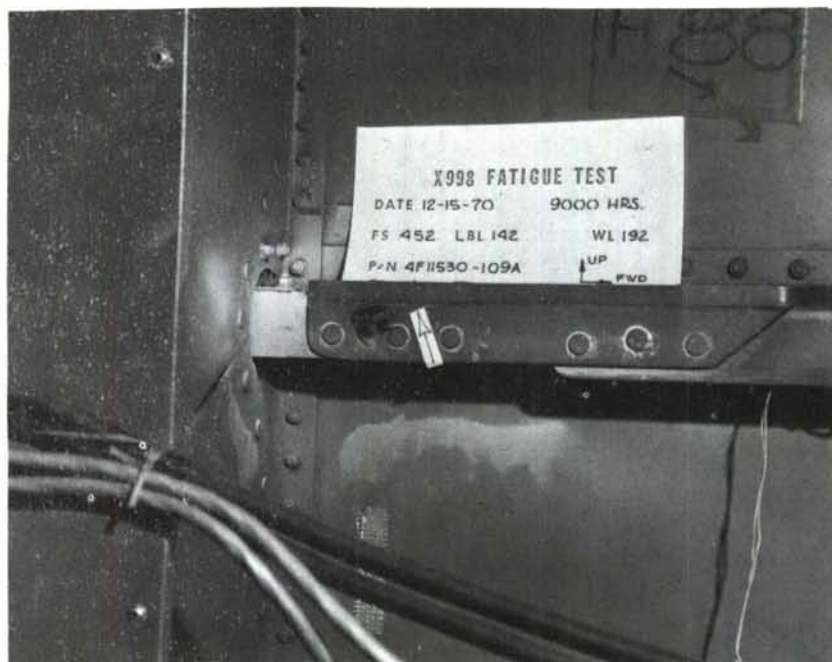
FIGURE 123. FATIGUE DAMAGE AT FUSELAGE STATION 452
